Fort Bend
County Courthouse
Tower Clock Dials

Tower Clock Restoration Agreement

County FORT BEND City RICHMOND State TEXAS

Make of clock: E. HOWARD Serial number NONE

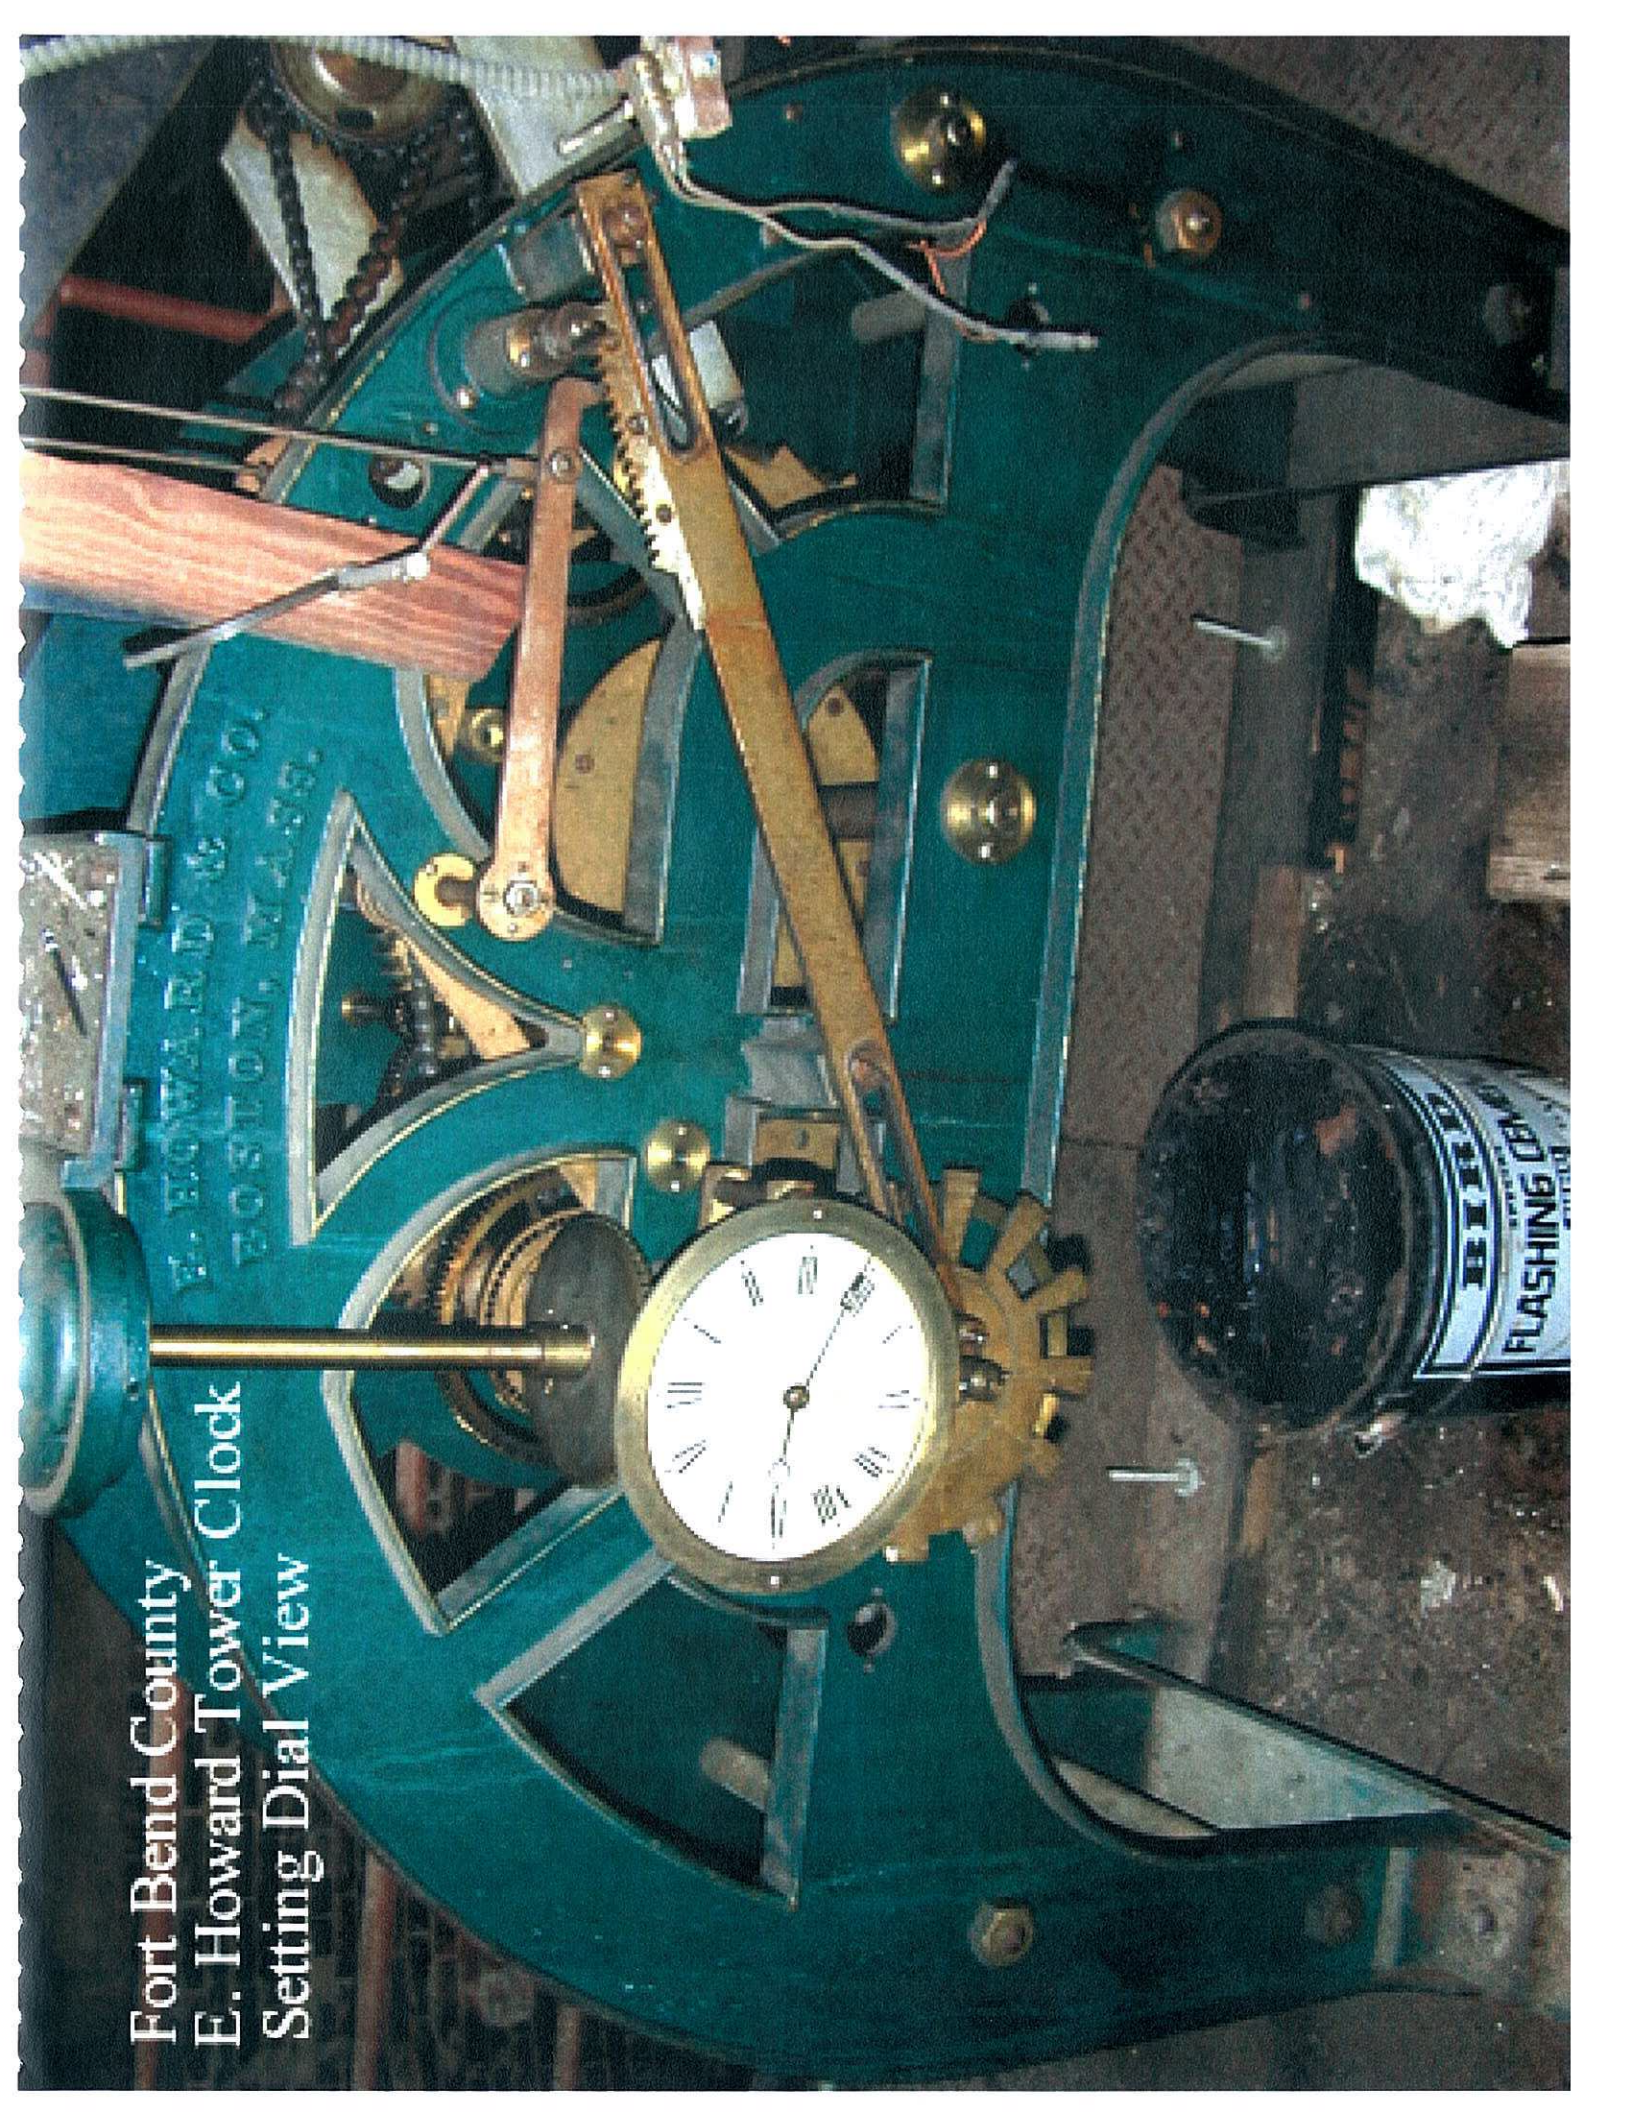
Present condition: THE CLOCK IS EXTREMELY DIRTY AND GUMMED UP WITH CONTAMINATED OIL AND GREASE. RUST AND CORROSION ARE ON UNPAINTED PARTS. THERE ARE UNCONVENTIONAL ATTEMPTS TO REPAIR THE RACK AND SNAIL. THE GATHERING PALETS ARE INCORRECTLY MOUNTED USING HARDWARE NOT ORIGINAL TO THE CLOCK.

Fort Bend County
E. Howard Tower Clock
Setting Dial View

Recommendations for restoration: A FULL RESTORATION OF THE CLOCK IS REQUIRED. THE CLOCK WILL BE DISASSEMBLED, LOWERED OUT OF THE TOWER, AND TRANSPORTED TO OUR RESTORATION SHOPS.

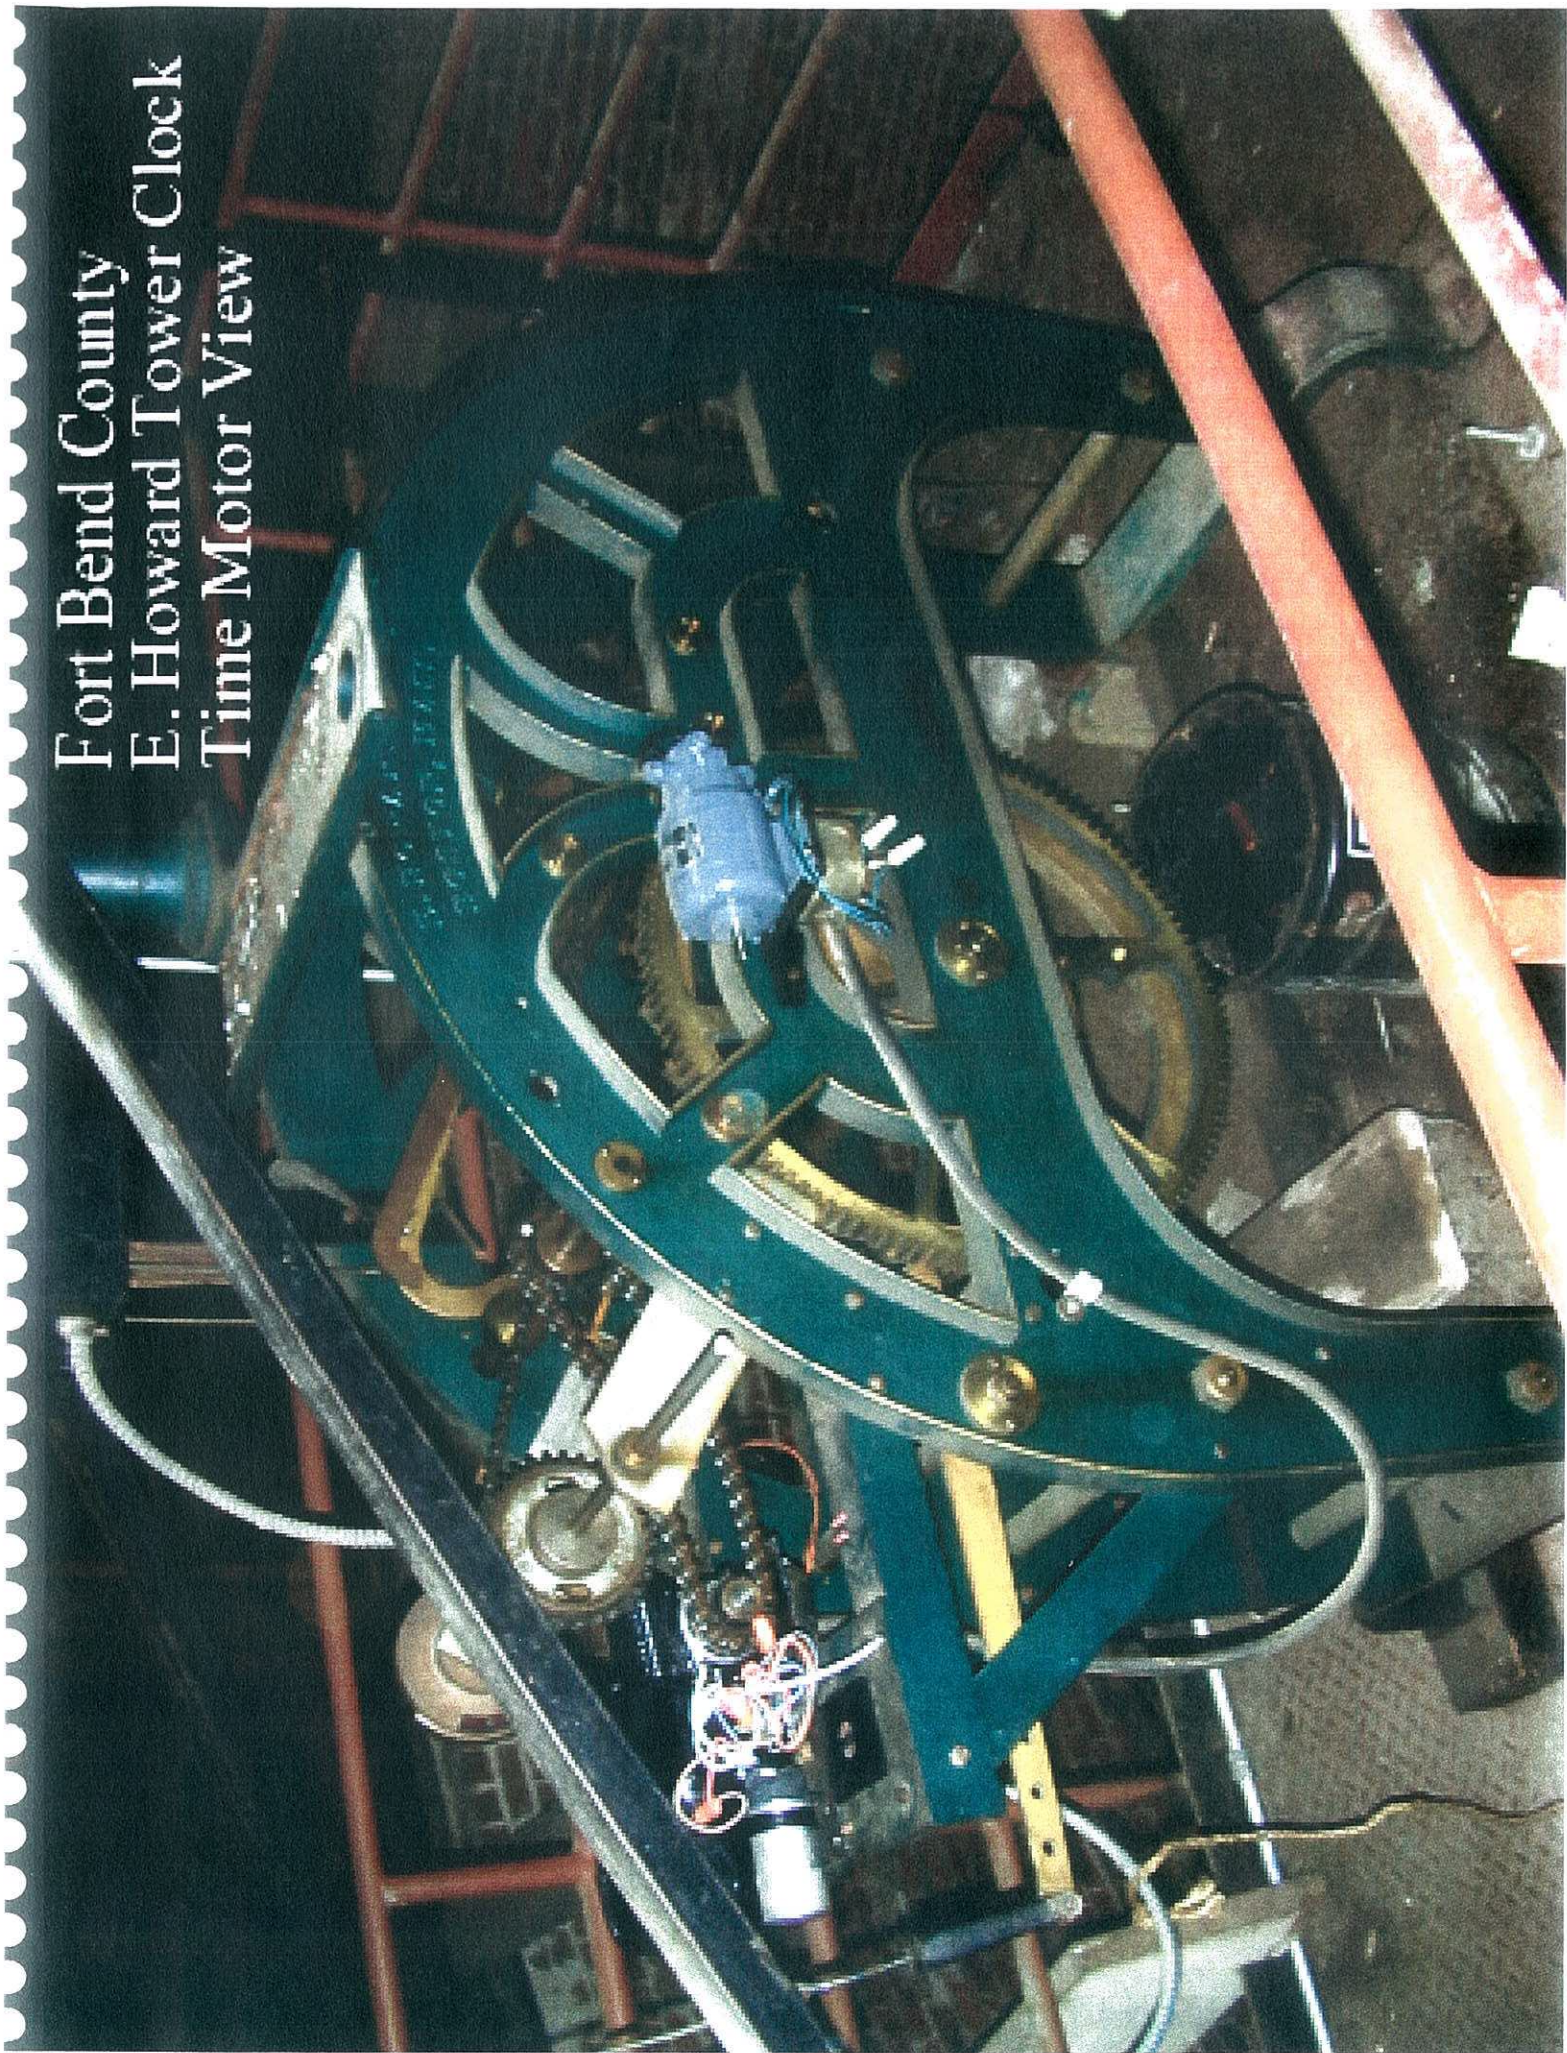
Fort Bend County
E. Howard Tower Clock
Time Motor View
